RESEARCH TECHNICAL REPORT

Corrosion and Corrosion Mitigation in Fire Protection Systems

Paul Su and David B. Fuller

2nd Edition, July 2014

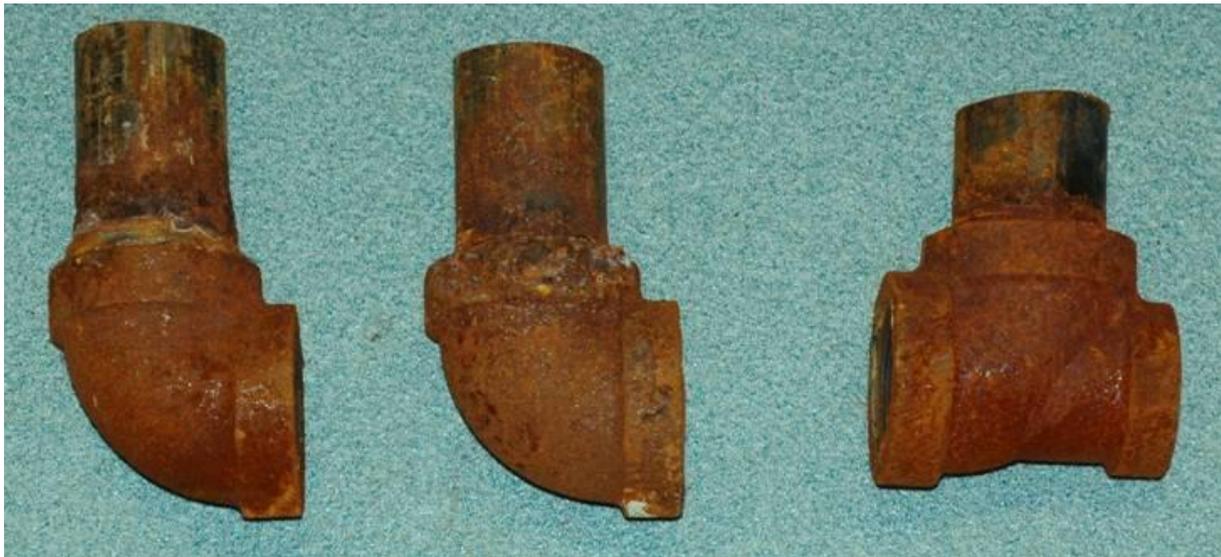
Figure 4.2 Uniform corrosion of steel sprinkler pipe joints (2 inch dia.) in a wet pipe system caused by water leakage past their thread joints.

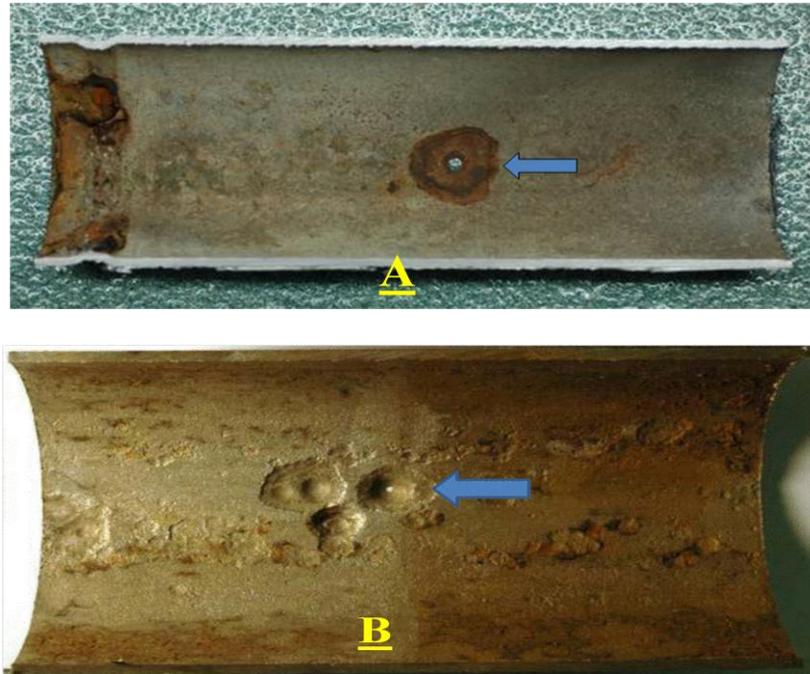
Figure 4.5 (A) Through-wall leakage of pitting at the bottom of a NPS 3 (3.5 inch OD) galvanized steel sprinkler pipe in a dry pipe system. (B) Through-wall leakage of pitting at the bottom of a NPS 3 black steel sprinkler pipe in a wet pipe system.

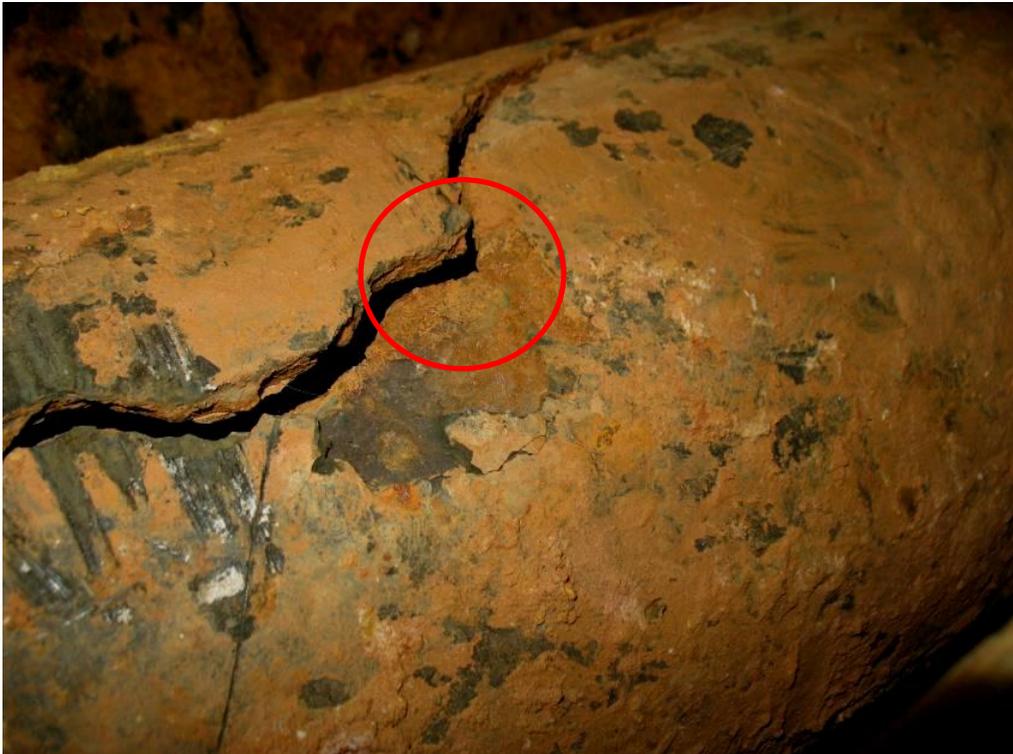
Figure 4.7 shows a ruptured underground water main (identified as gray cast iron, 8-inch diameter) with cement lining on the main's inside diameter. The circled area in Figure 4.7 exhibits graphitic corrosion on the outside surface of the main due to its exposure to mildly aggressive groundwater and soils. Generally, high moisture content in the surrounding soil is required for graphitic corrosion to occur.

Figure 4.7 Photograph showing a ruptured underground water main (8 inch dia.) with circled area indicative of graphitic corrosion.

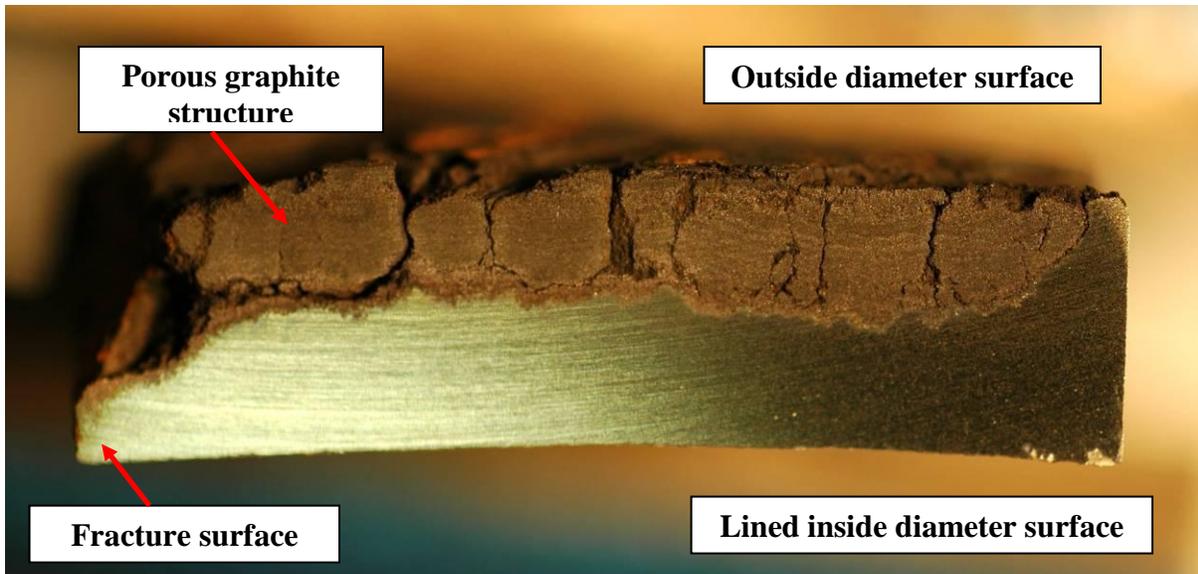
Figure 4.8 Photograph showing the cross section for part of the water main in Figure 4.7. Almost the entire wall thickness of the pipe has been penetrated by graphitic corrosion attack at the far left fracture face.

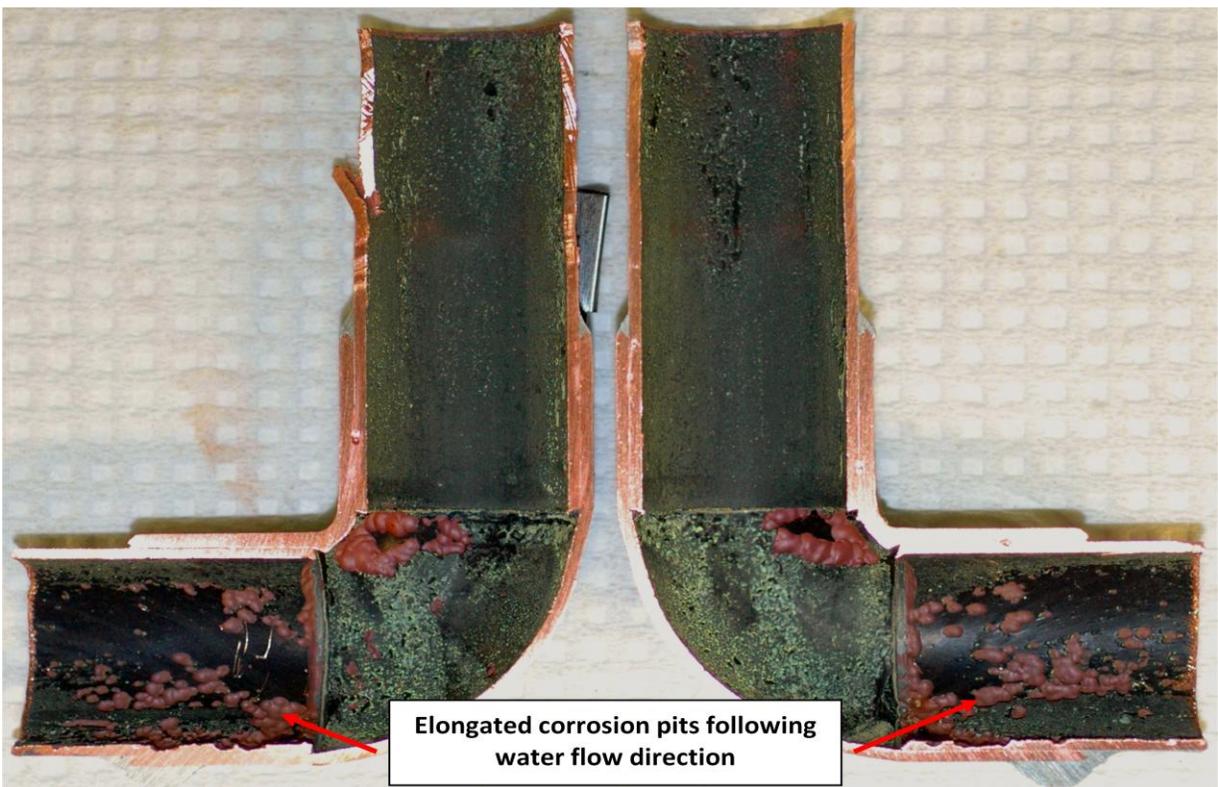
The black and greenish materials shown in Figure 4.9 are different forms of copper corrosion products, such as cupric oxide (CuO , black), cuprous oxide (Cu_2O , reddish-brown), and malachite [$\text{Cu}_2(\text{CO}_3)(\text{OH})_2$, blackish green].²³ It should be noted that corrosion of copper piping in FPS can be caused by aggressive water quality/chemistry parameters²³, such as sprinkler water with pH values ranging from 7.0 to 7.7, stagnant water with air pocket supplying dissolved carbon dioxide (CO_2) and oxygen (O_2), dissolved anions (chloride and sulfate), low alkalinity and by residual soldering flux during fabrication of copper pipe joints.^{24,25}

Figure 4.9 Photograph showing erosion corrosion (elongated corrosion pits following water flow direction) in a copper domestic water line.

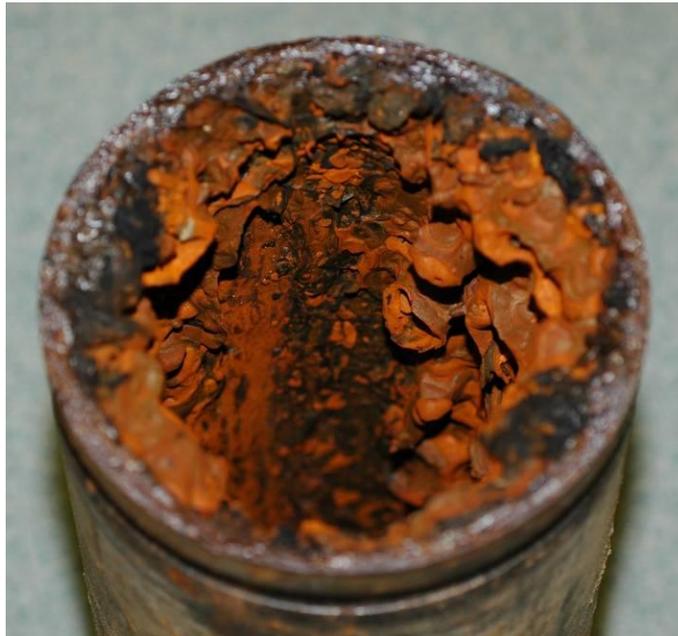
Figure 4.15 Photograph showing a corroded/leaked steel sprinkler pipe (4 inch dia.) with many tubercles. MIC caused by SRB was identified to be a likely contributing factor to pipe corrosion.

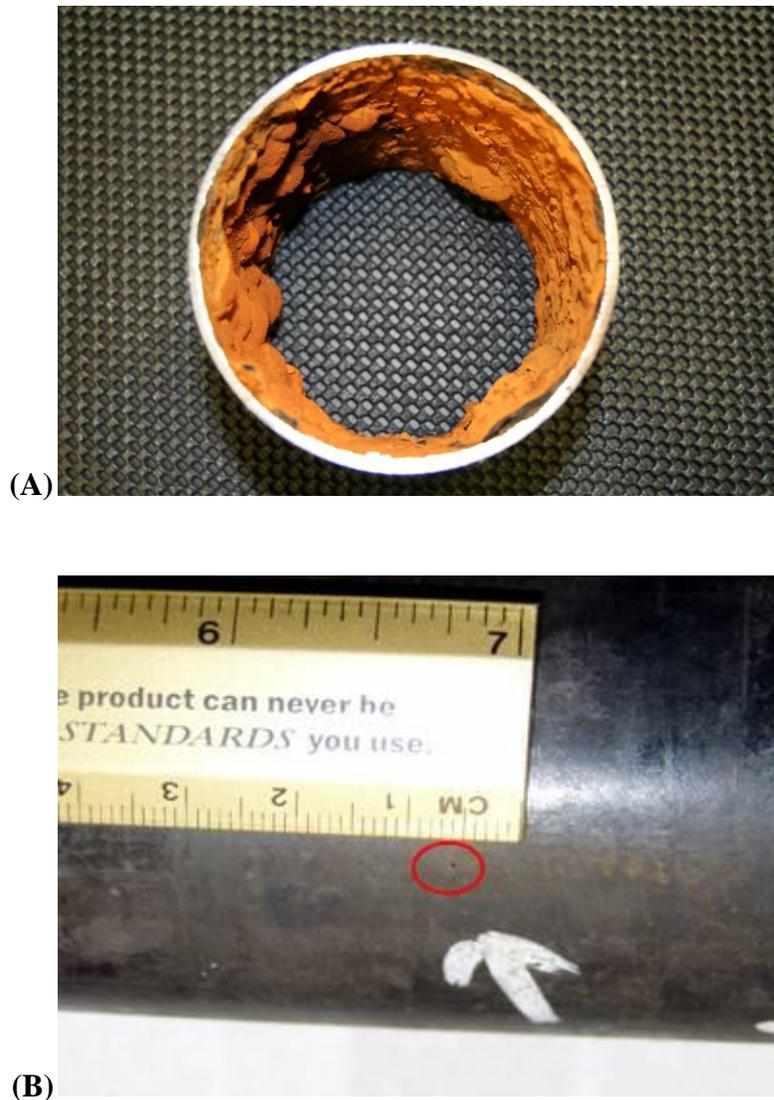
Figure 4.16 Photograph showing tubercles and pinhole (circled) leakage of steel sprinkler pipe in wet pipe systems. (A) Tubercles heavily formed inside a steel sprinkler pipe (4 inch dia.). (B) Pinhole (circled) leakage on a steel sprinkler pipe.

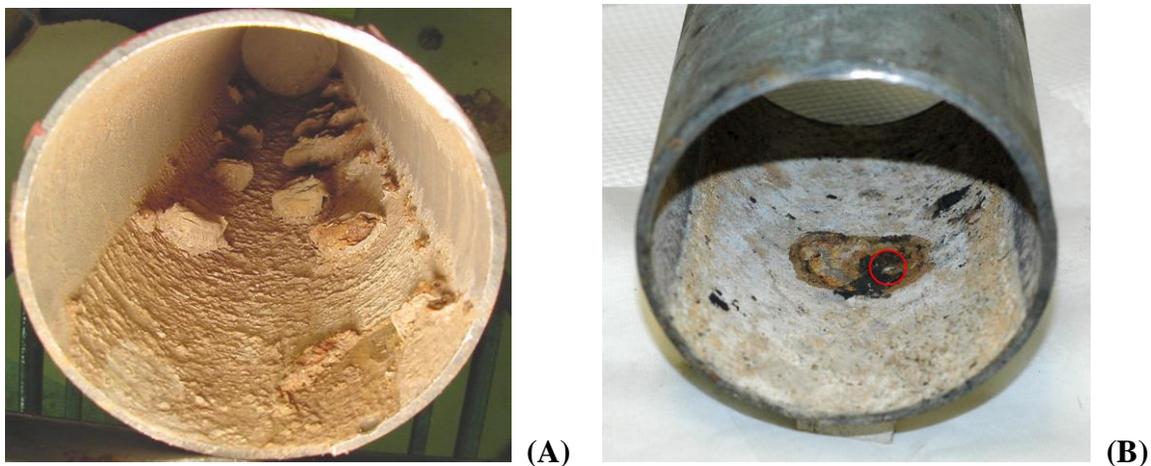
Figure 4.17 (A and B) shows tubercles and pinhole (circled) leakage of galvanized steel sprinkler pipe in dry pipe systems. Tubercles heavily formed inside a galvanized steel sprinkler pipe (4 inch dia.) are seen in Figure 4.17 (A); corrosion products such as white zinc oxide (ZnO) and zinc hydroxide ($\text{Zn}(\text{OH})_2$) cover non-tubercle surfaces. Figure 4.17 (B) shows corrosion at the base of a tubercle, which ultimately led to the observed through-wall leakage.

Figure 4.17 Photograph showing tubercles and pinhole (circled) leakage of galvanized steel sprinkler pipe in dry pipe systems. (A) Tubercles heavily formed inside a galvanized steel pipe (4 inch dia.). (B) Through-wall (circled) leakage underneath a tubercle (removed) on a galvanized steel pipe.

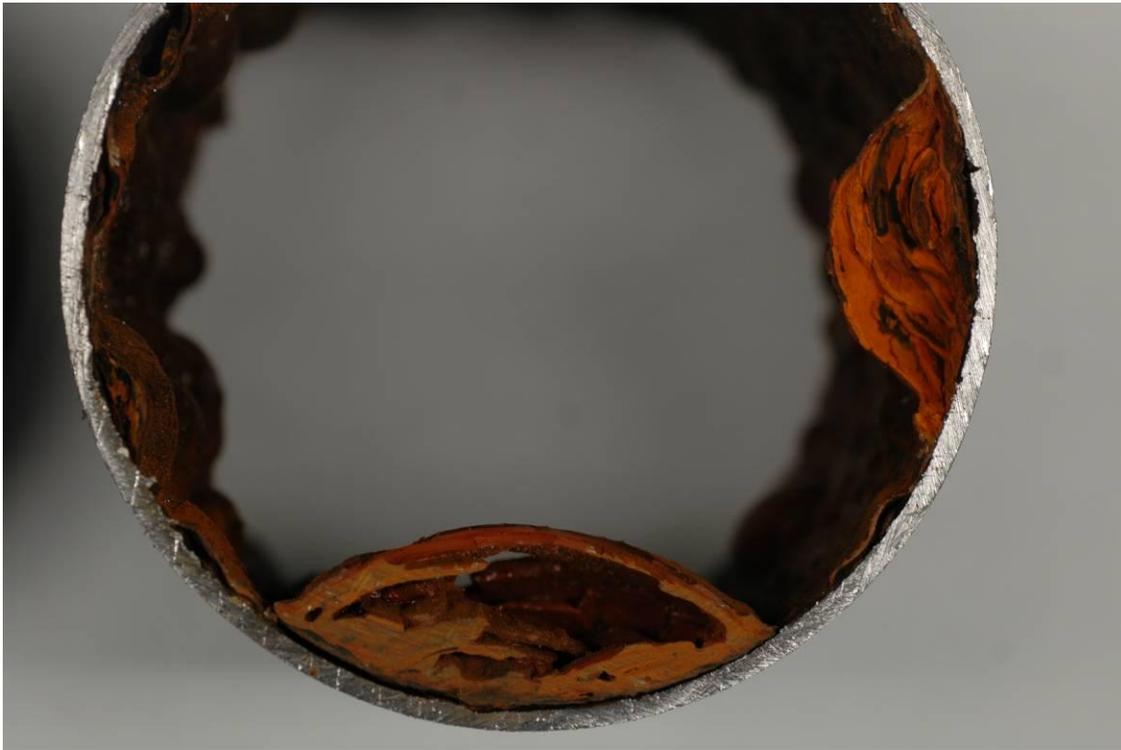
Figure 4.19 shows the cross section of several non-MIC tubercles in a NPS 4 Schedule 10 steel sprinkler pipe. Irregular shapes of cavities are visible inside two larger tubercles. The orange and brown-like layers of corrosion product are likely to be hydrated iron(III) oxides $\text{Fe}_2\text{O}_3 \cdot n\text{H}_2\text{O}$ and iron(III) oxide-hydroxide ($\text{FeO}(\text{OH})$) and the black layers of material could be magnetite (Fe_3O_4). In this case, intermittently charging oxygenated water into the system may have created oxygen concentration cells and changed the local water chemistry in the steel pipe, resulting in promoting the growth of tubercles.

Figure 4.19 Photograph showing the cross section of non-MIC tubercles in a NPS 4 Schedule 10 steel sprinkler pipe. Irregular shapes of cavities are visible inside two larger tubercles.

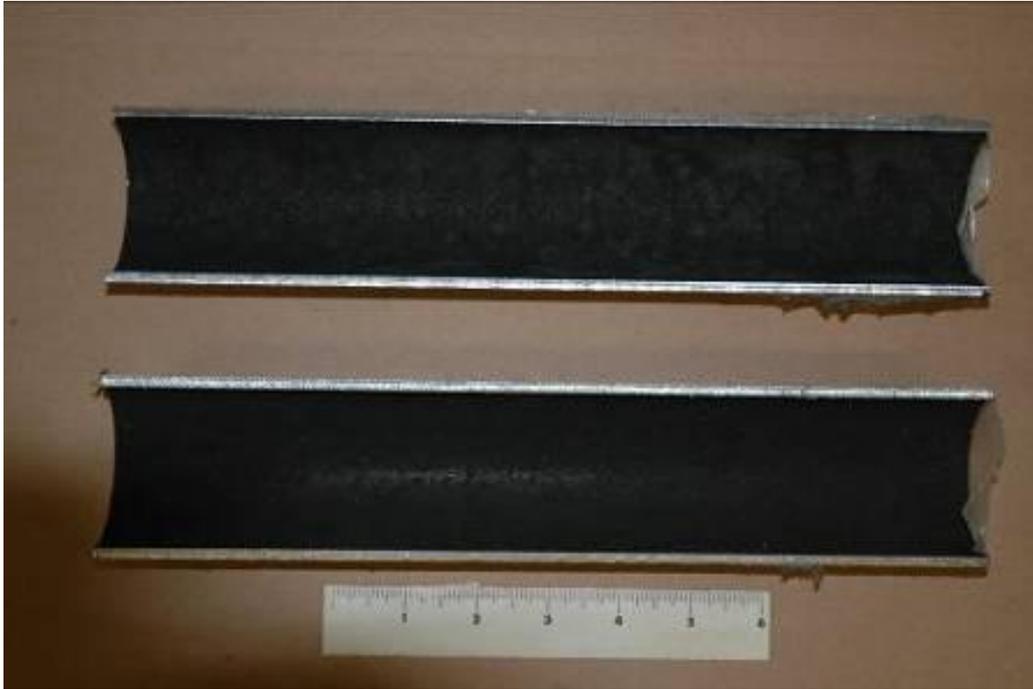
Figure 4.20 shows steel pipe in a wet pipe system with limited corrosion forming a layer of black magnetite (Fe₃O₄) on its internal pipe surface. This magnetite layer was created when oxygen in the initial aerated water reacted with the steel pipe and was depleted. Limiting the oxygen supply and reducing its concentration in FPS can substantially mitigate corrosion.

Figure 4.20 Photograph showing steel pipe in a wet pipe system with limited corrosion after forming a layer of black magnetite and depleting oxygen inside this piping system.

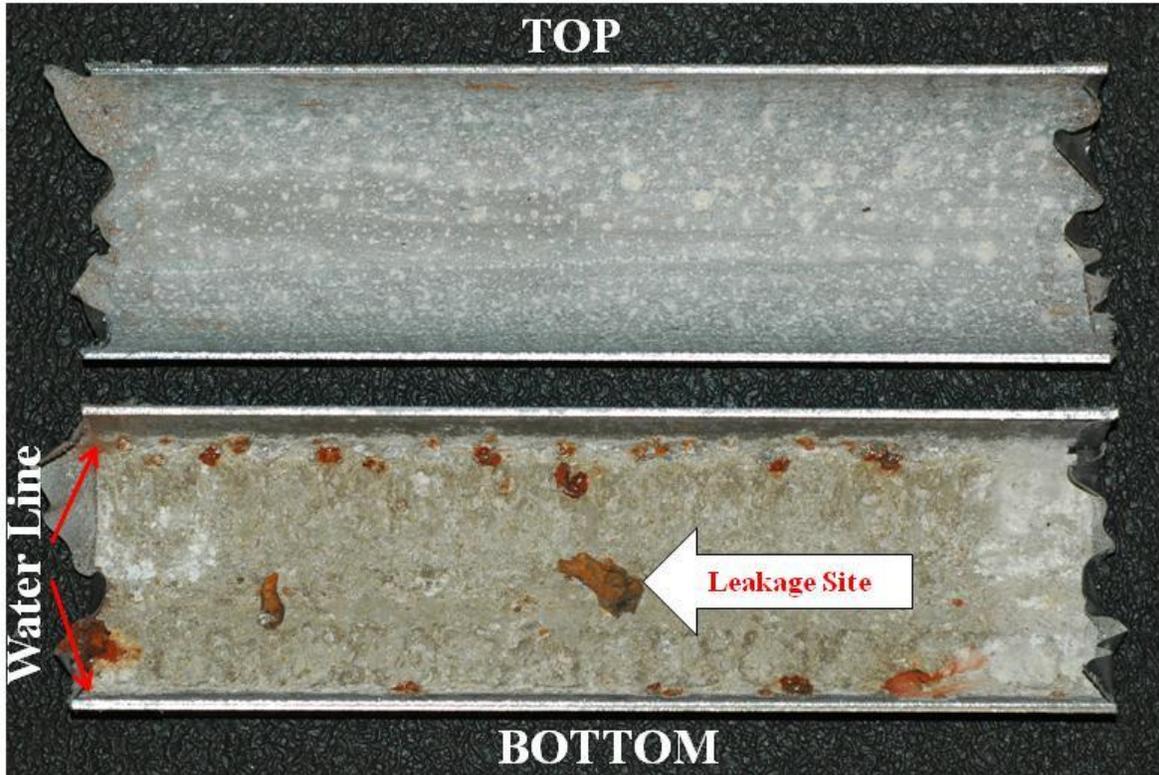
Figure 4.21 Photograph showing NPS 4 galvanized steel pipe (4.5 inch OD) with a through-wall leakage. Residual water filled about 40% of the pipe's volume in service. Under the waterline, white rust and well over a dozen reddish-brown tubercles of various sizes are evident on the bottom half of the pipe.

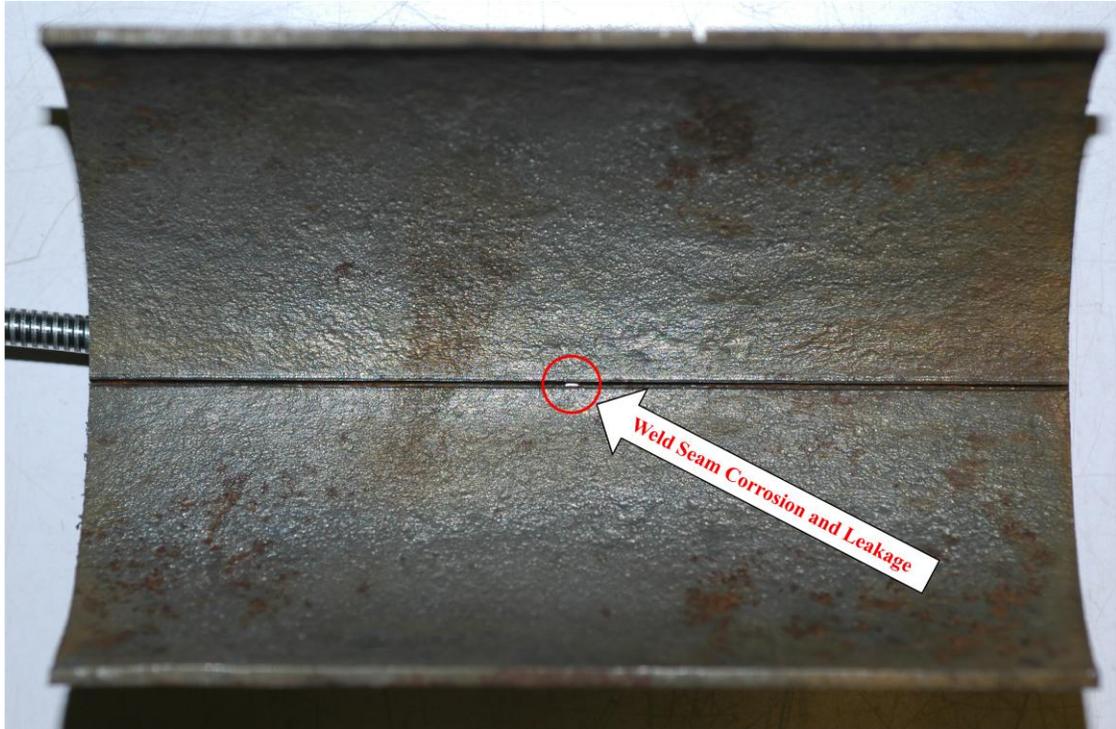
Figure 5.2 Photograph showing preferential grooving corrosion on pipe weld seam with a 1 mm pinhole leak in a wet pipe system, after removing corrosion products inside an NPS 3 pipe.

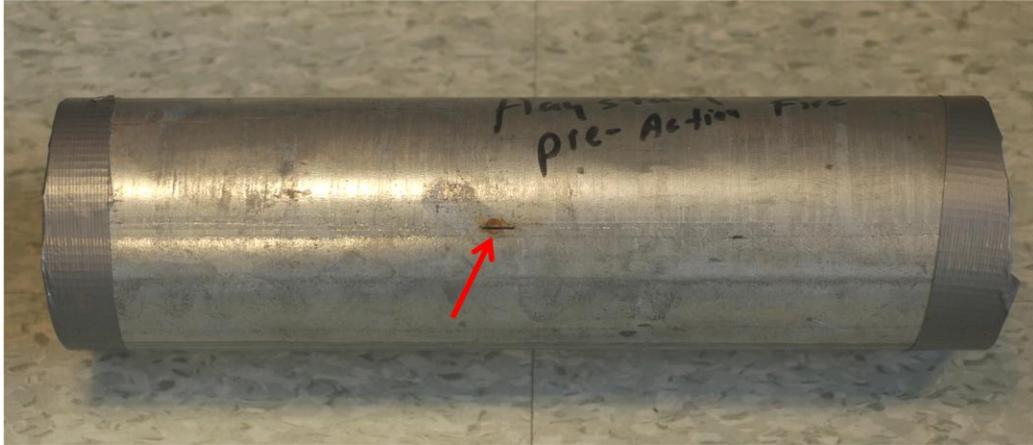
Figure 5.3 Photograph showing the outside of the bottom half of the pipe in Figure 4.21. The arrow points a longitudinal through-wall leakage site on the pipe in a preaction system.

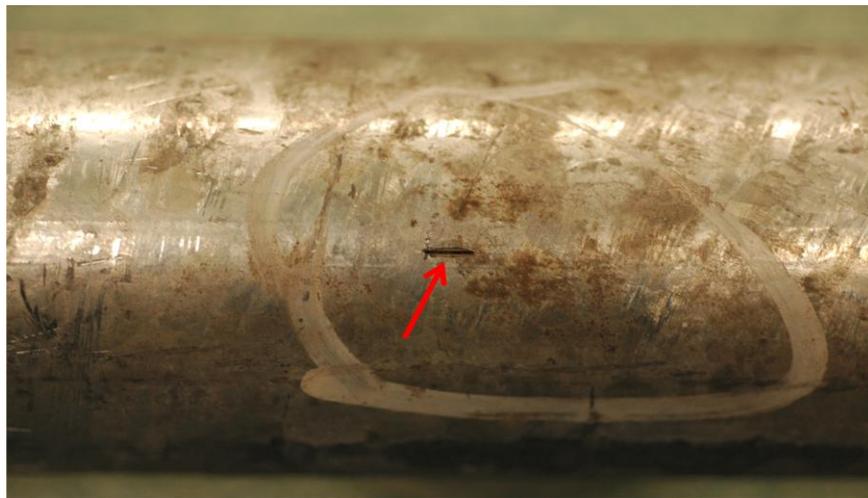
Figure 5.4 Photograph showing preferential grooving attack surrounding the weld seam area in a preaction system.

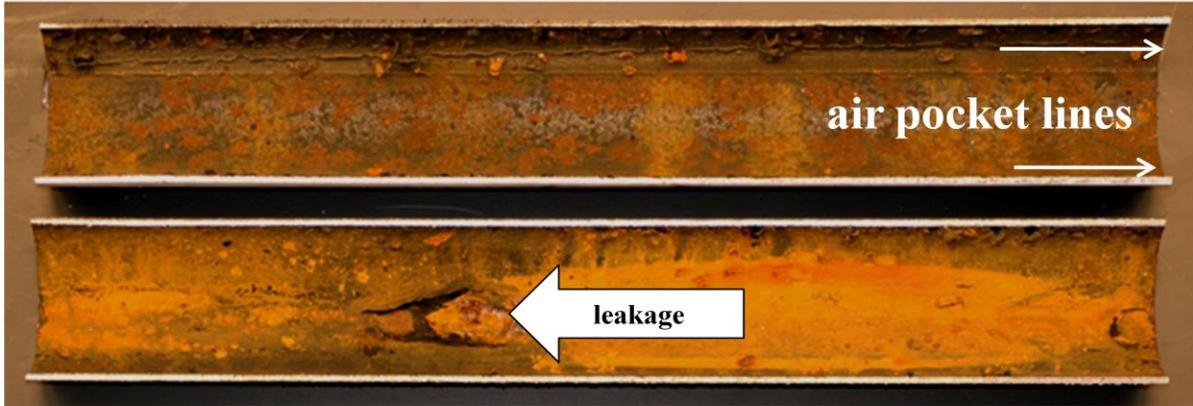
Figure 5.5 Photograph showing the leakage section of a pipe where the air gap filled approximately 40% of the volume in a wet pipe system.

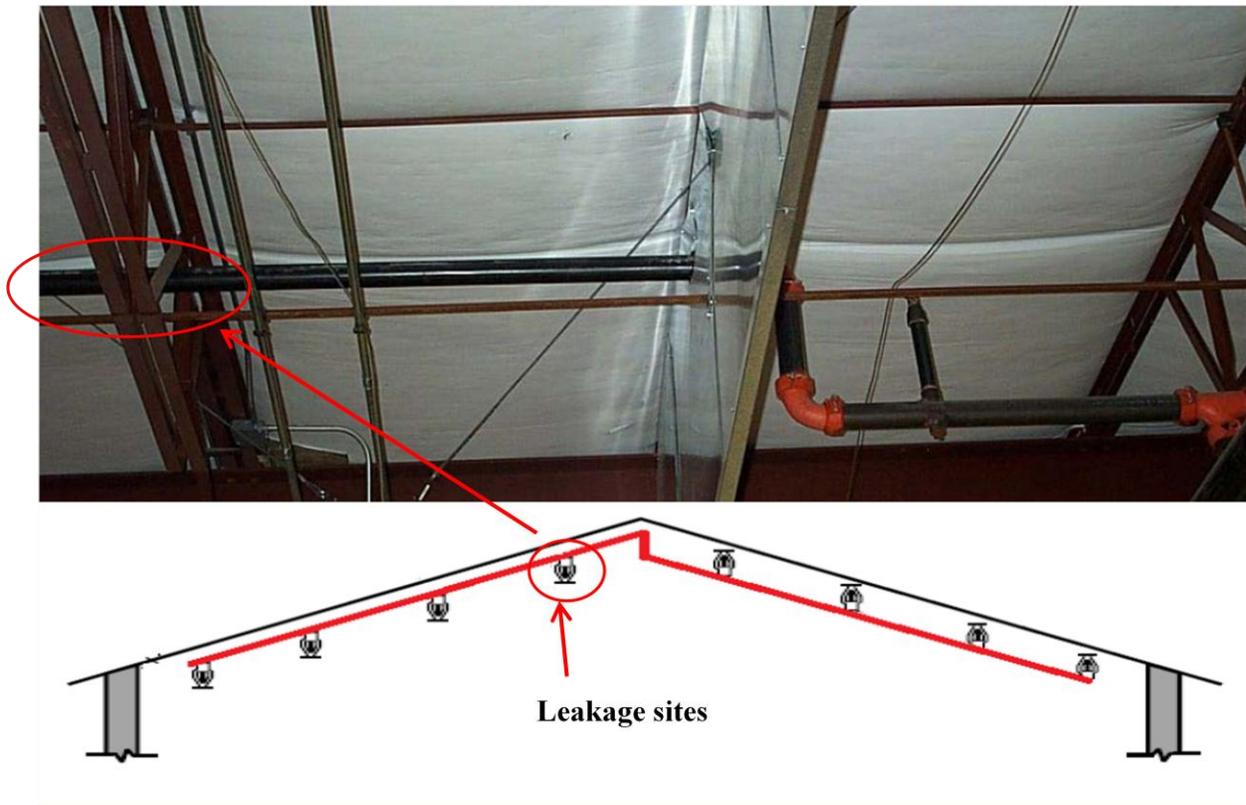
Figure 5.6 Photograph showing leakage sites in a wet pipe system due to trapped air.

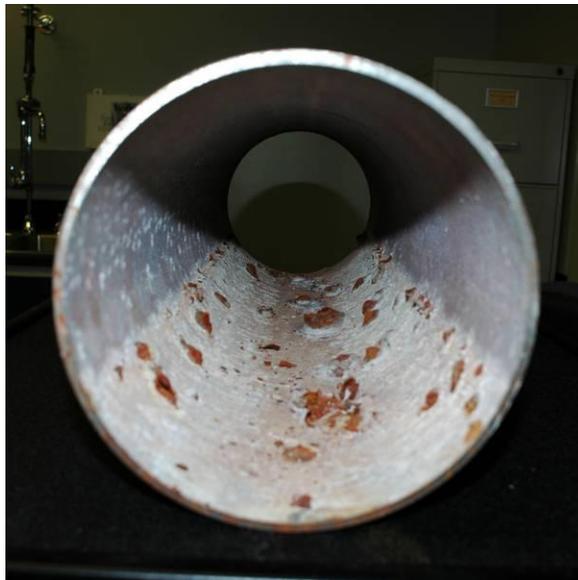
Figure 5.7 Photograph showing corrosion of galvanized steel pipe (NPS 6, Schedule 10) where residual water filled about 40% of the pipe's volume in a dry pipe system.

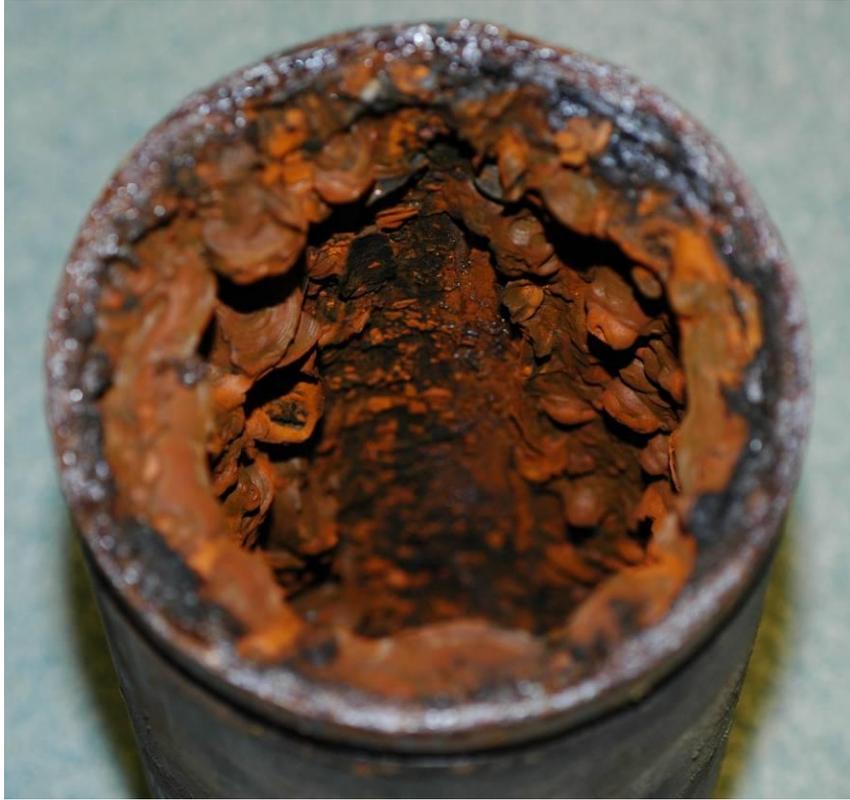
Figure 5.10 Photograph showing extensive tuberculation and deposit buildup for a portion of the Pipe Sample #1 in Table 5.2.

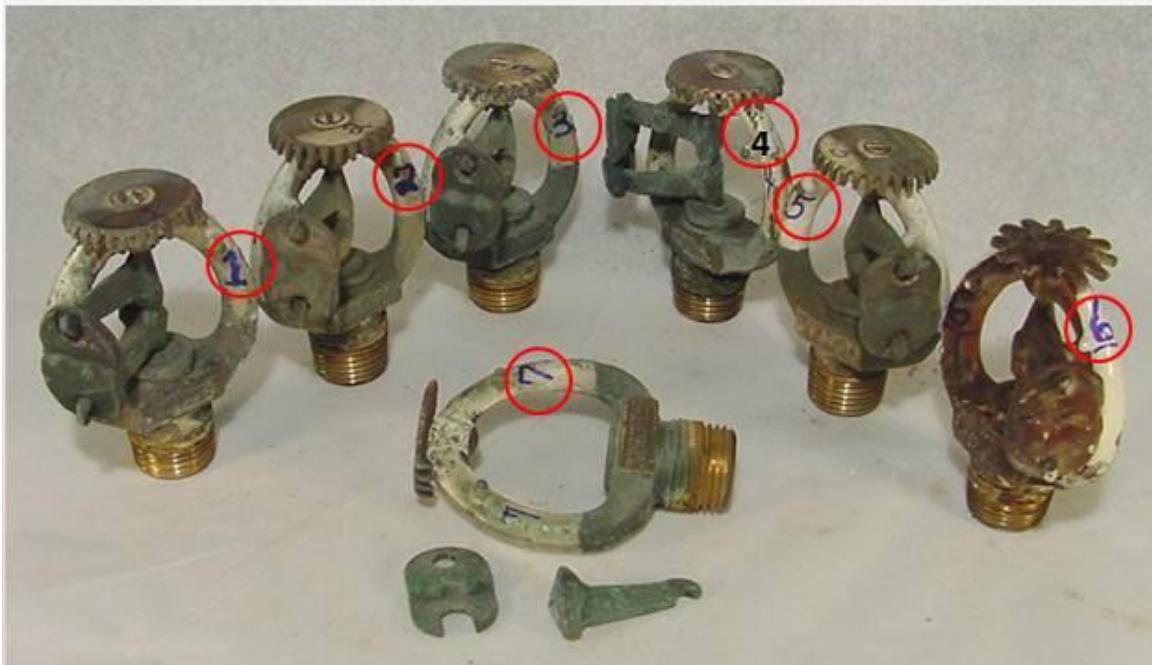
Figure 5.13 Photograph showing six intact (top, #1-6) and one prematurely operated (bottom, #7) sprinkler heads. The #7 sprinkler's fusible link halves had separated during the premature operation incident.

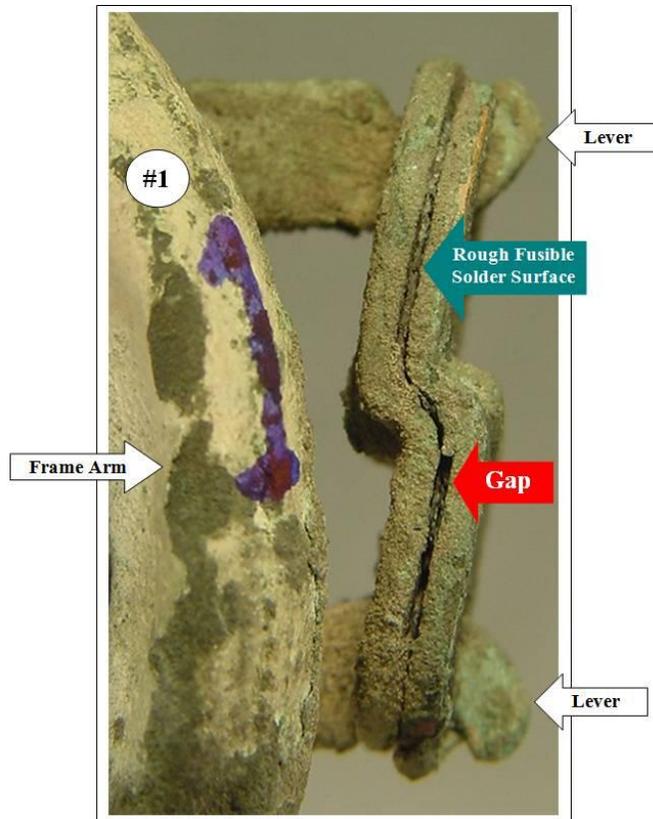
Figure 5.14 Photograph showing a side view of the fusible link halves from Sprinkler #1. A significant gap is present between the two link halves. The exposed surface of the fusible solder visible between the link halves has a rough surface, consistent with corrosion attack.

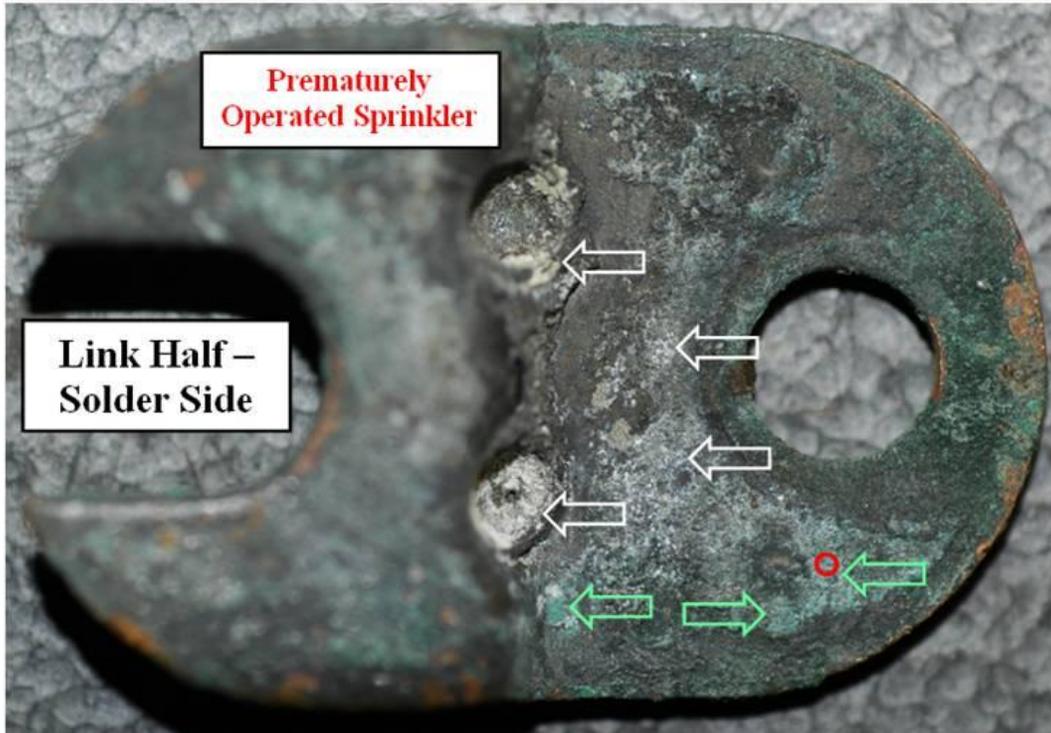
Figure 5.15 Close-up photograph of the fracture surface (solder side) of the link half from the prematurely operated sprinkler.
