RESEARCH TECHNICAL REPORT

Corrosion and Corrosion Mitigation in Fire Protection Systems

Paul Su and David B. Fuller

2nd Edition, July 2014

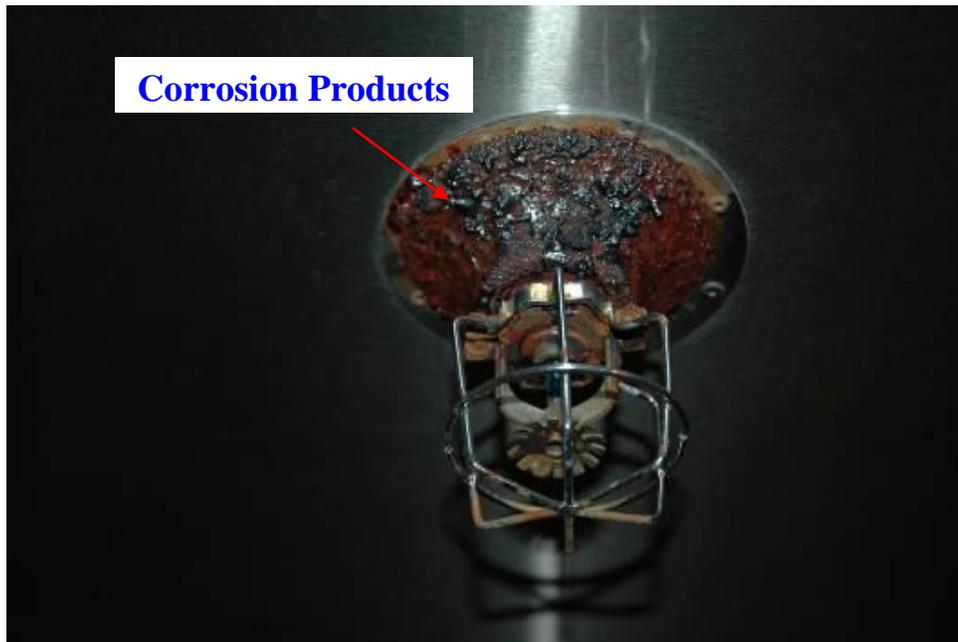
Figure 4.3 Photograph showing galvanic corrosion damage of a less noble steel connection (anode) contacting a large noble stainless steel plate (cathode) inside a high humidity environmental chamber.

Figure 4.3 shows galvanic corrosion damage of a less noble steel connection (anode) contacting a large noble stainless steel plate (cathode) inside a high humidity environmental chamber

without proper electrical insulation between these two metals. The deposits shown in Figure 4.3 are the corrosion products of the steel connection.

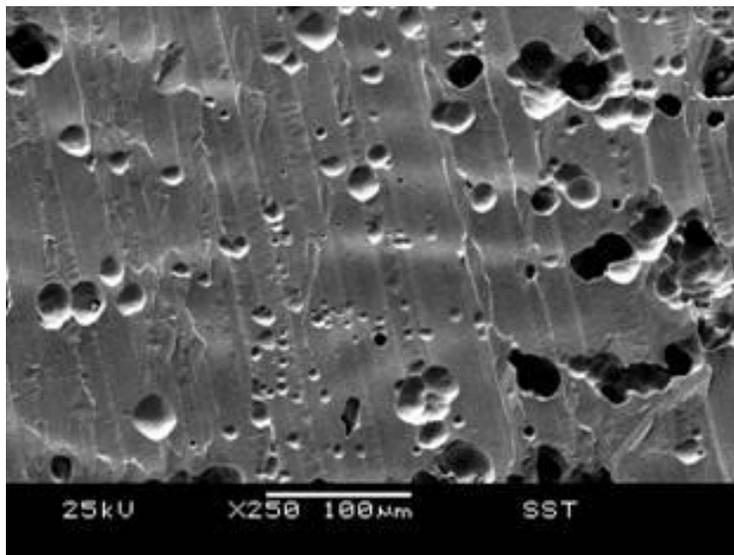
Figure 4.4 SEM photograph showing pits on a metal surface.

Figure 4.4 shows an scanning electron microscope (SEM) image of pits on a metal surface. It is noted that corrosion took place locally at many pits, while other areas on the metal surface are relatively intact.²⁰ The solution inside a pit can be very aggressive (e.g., acid with pH ~2 and Cl⁻), which increases the metal dissolution rate and is often called an autocatalytic process.

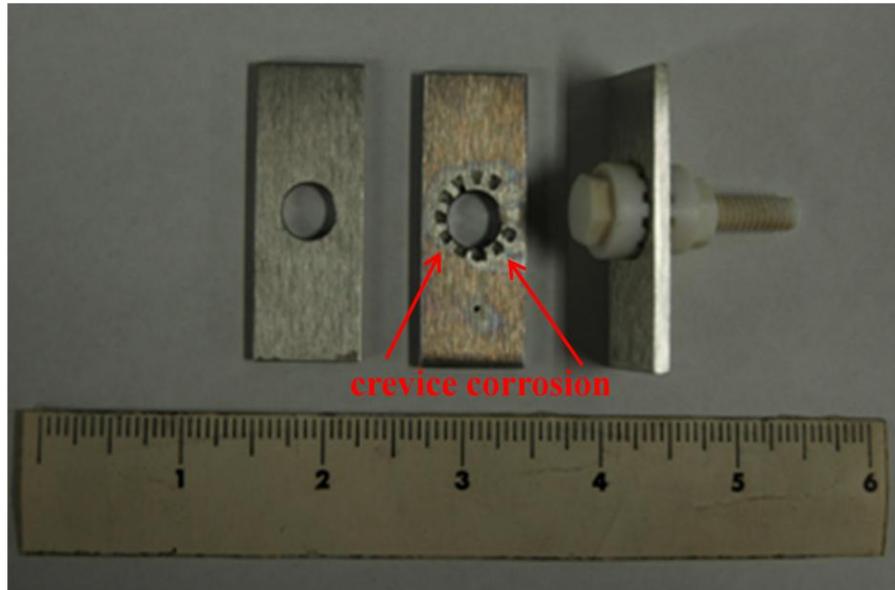
Figure 4.6 Photograph showing localized crevice corrosion attacks on a metal coupon (middle) underneath a PTFE artificial crevice washer at 75°C after 48 hours of exposure.

Figure 4.6 shows localized crevice corrosion attacks on a metal coupon (middle) underneath a polytetrafluoroethylene (PTFE) artificial crevice washer at 75°C after 48 hours of exposure.

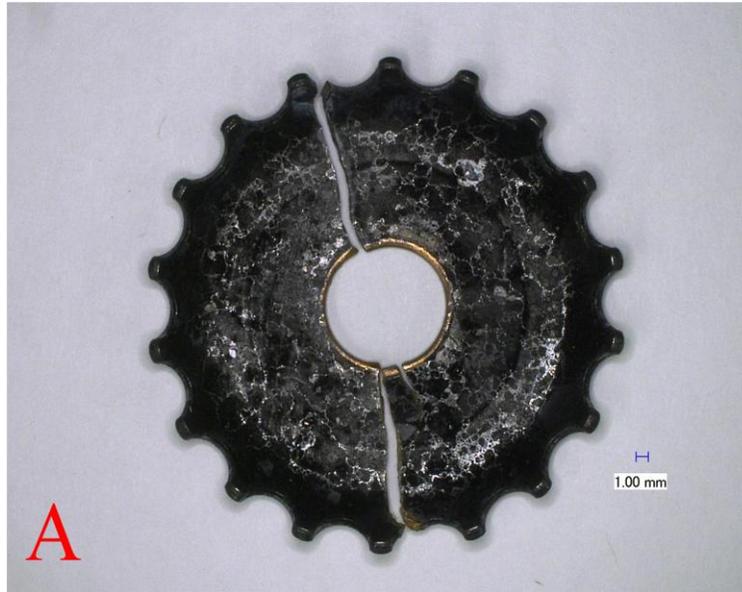
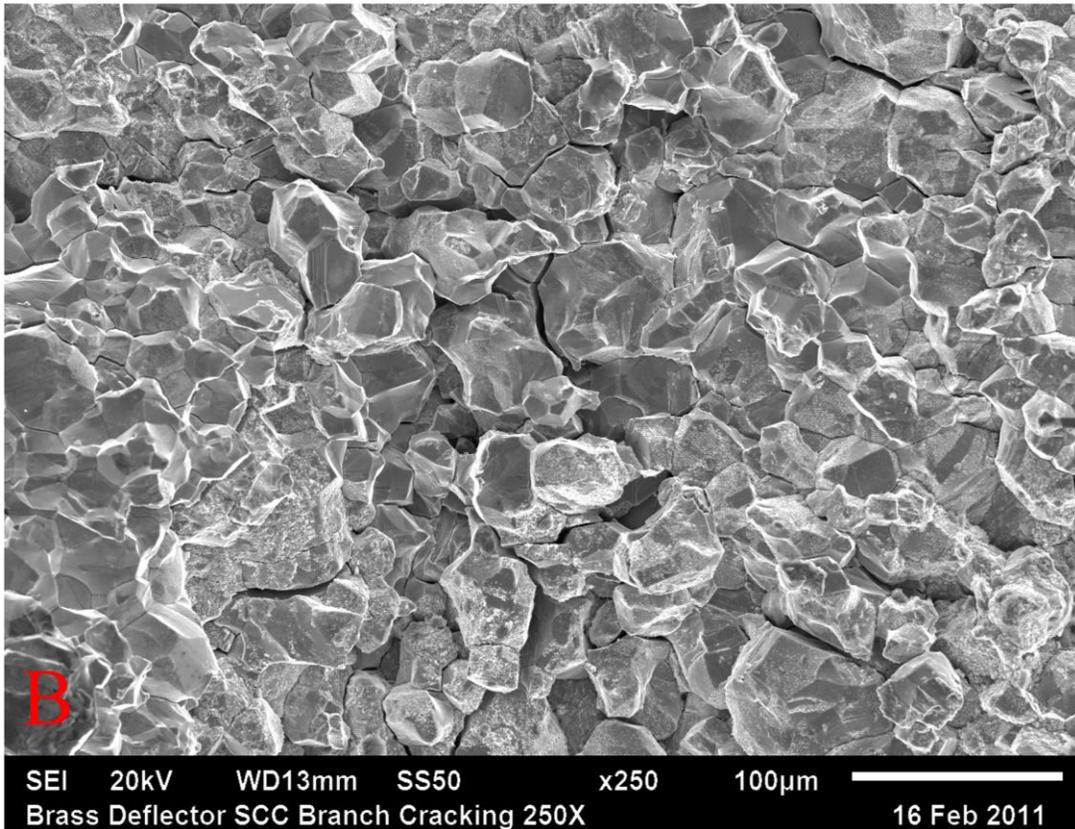
Figure 4.10 (A) Photograph showing SCC failure across the deflector of a brass sprinkler after the ammonia SCC testing. (B) SEM photograph of cracking morphology for fracture surface on the deflector in Figure 4.10 (A).

Brass sprinklers can experience SCC failure under ammonia atmosphere. Ammonia SCC testing is used in FM Global Approval Standards (e.g., “Automatic Control Mode Sprinklers for Fire Protection Class Number 2000”) to evaluate the SCC resistance of copper-based (e.g., brass) sprinklers. Figure 4.10 (A) shows SCC failure across the deflector of a brass sprinkler after ammonia SCC testing. Figure 4.10 (B) displays an image of cracking morphology for fracture surface on the deflector in Figure 4.10 (A), taken by scanning electron microscope (SEM, JEOL JSM-6610LV). The cracking morphology showing intergranular cracking (fracture) is a typical characteristic of SCC where grain boundaries in the brass deflector were attacked by ammonia, resulting in brittle fracture.

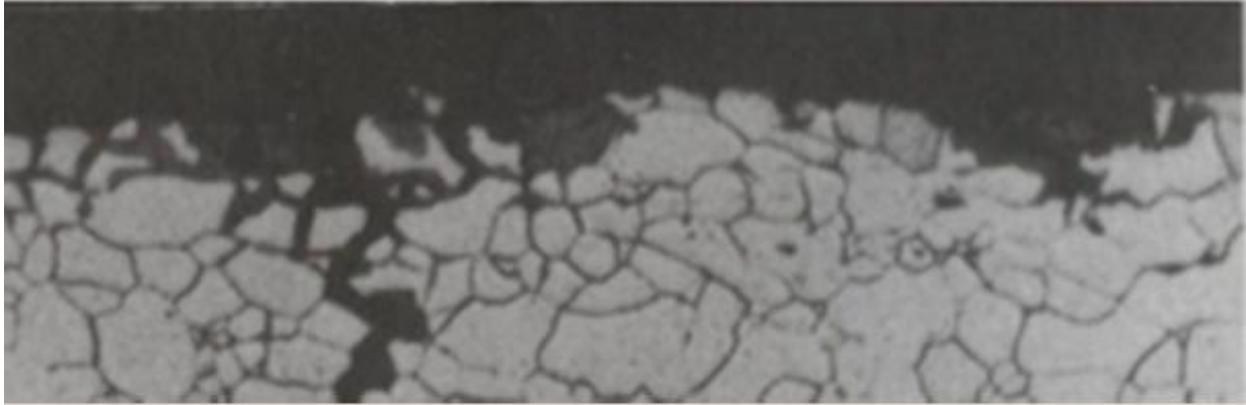
Figure 4.11 shows IGC and cracking of steel where the corrosion and cracking occurred along grain boundary areas without corroding the steel grain matrix.

Figure 4.11 Photomicrograph showing intergranular corrosion of steel surface where corrosion and cracking occurred along grain boundaries without corroding the steel grain matrix.

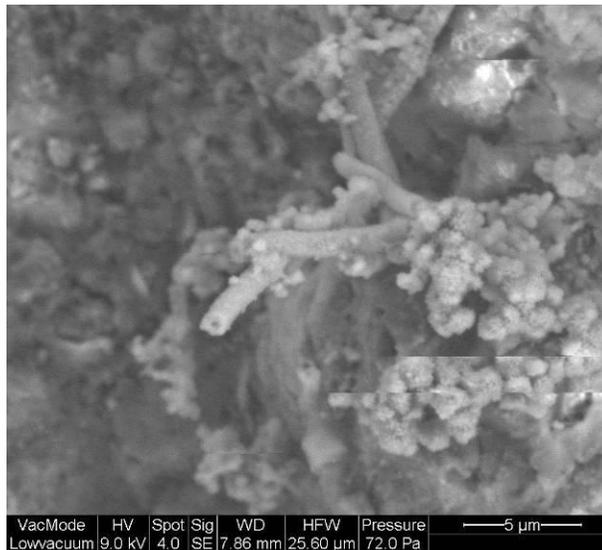
Figure 4.13 Representative SEM image of corroded steel with bacteria. The corrosion product, drinking straw-like structure, may be due to *Leptothrix ochracea*, iron-oxidizing bacteria on corroded steel pipe.

Figures 4.13 and 4.14 show representative SEM images of corroded steel with bacteria, indicating bacterial involvement in the corrosion process (i.e., MIC). Figure 4.13³⁴ displays an image of corroded steel pipe with corrosion product containing a drinking straw-like structure, which may be due to *Leptothrix ochracea* (iron-oxidizing bacteria). Figure 4.14⁴² displays rod-shaped *Desulfovibrio* sp. (SRB) on the galvanized steel surface after 8 hours of incubation. Figure 4.15 is an example of a 4 inch dia. corroded/leaked steel pipe with many tubercles formed inside the pipe. MIC caused by SRB was identified to be a likely contributing factor to pipe corrosion, based on testing results of SRB immunoassay, lead acetate sulfide tests, water chemistry analyses, and corrosion/metallurgical evidence (discussed in Section 5.5).

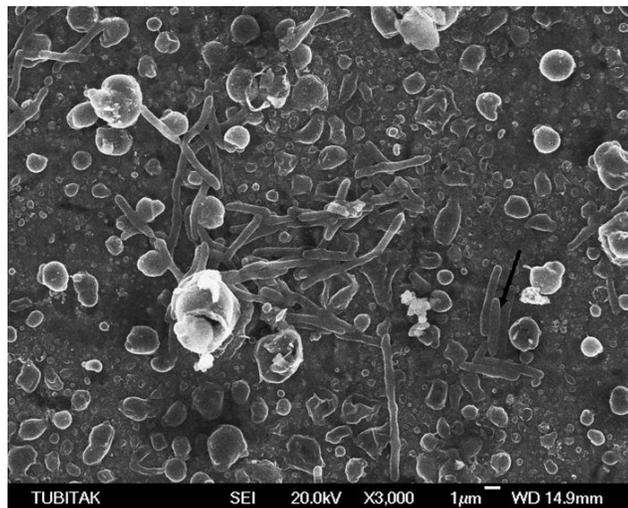
Figure 4.14 Representative SEM image of rod-shaped *Desulfovibrio* sp., sulfate-reducing bacteria on the galvanized steel surface after 8 hours of incubation.⁴² (Courtesy of Elsevier, August, 2011)

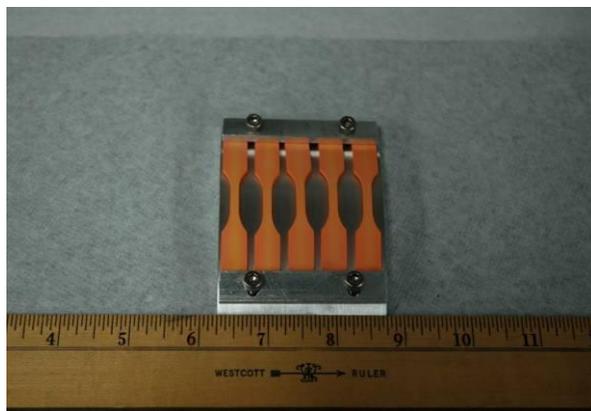
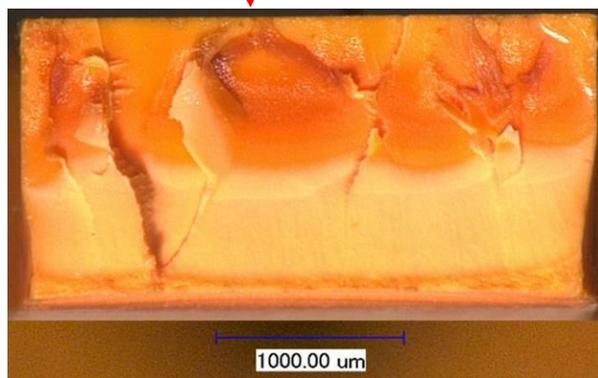
Figure 4.24 (A) shows five CPVC type V tensile specimens on a 1% strain jig for ESC testing of coating chemicals on black steel pipe.⁶⁰ Figure 4.24 (B) displays the fracture surface side view of a type V tensile specimen exposed to an ESC agent. The dark orange/glassy^{55,47} region indicates that the ESC agent has diffused into the specimen and the tensile stress has accelerated the diffusion process of this chemical; thus, eventually led to ESC fracture of the specimen.

Figure 4.24 Photographs showing (A) five CPVC type V tensile specimens on a 1% strain jig for ESC testing of coating chemicals on black steel pipe and (B) the fracture surface side view of a type V tensile specimen – ESC agent diffused into the specimen from exposed surface (top).

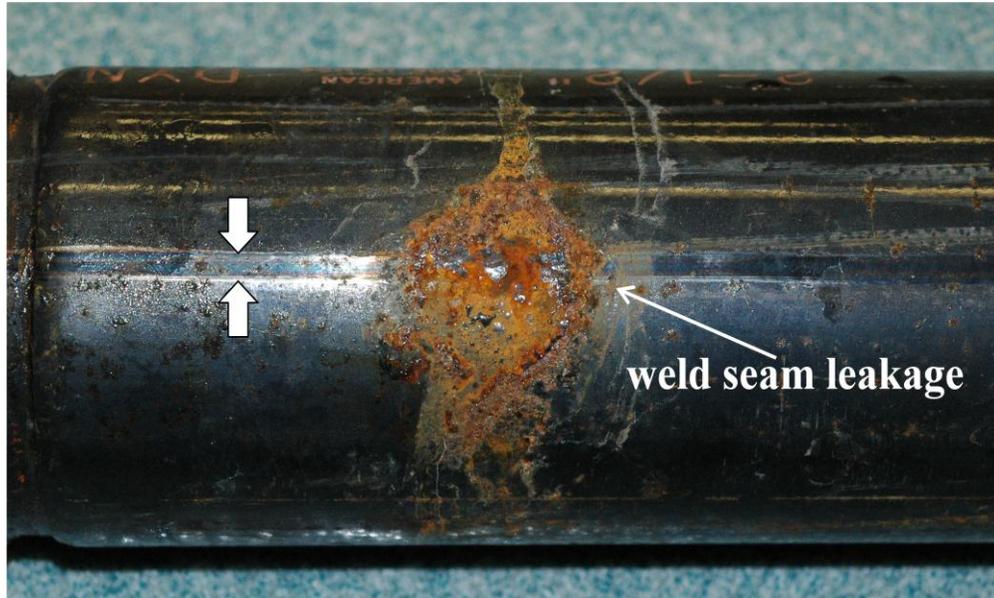
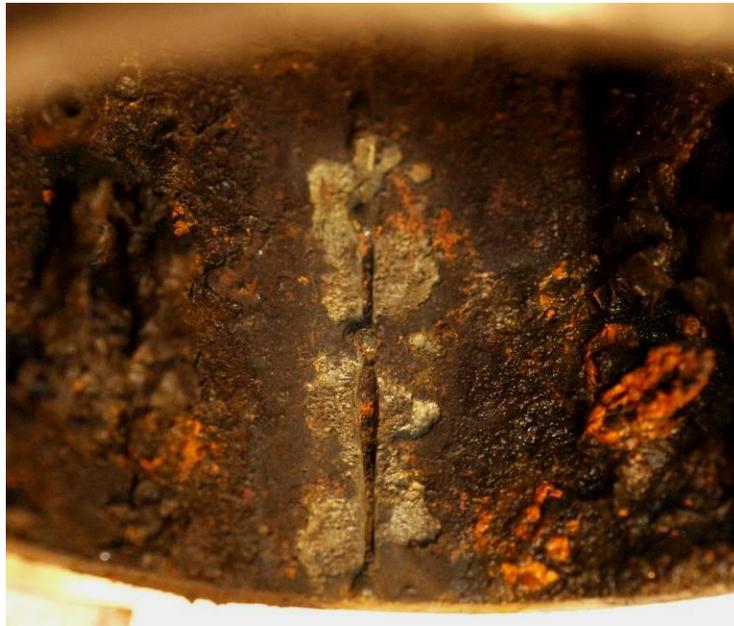
Figure 5.1 (A) and (B) shows leakage on an NPS 2½ steel sprinkler pipe in a wet pipe system. The weld seam leakage site and the location of the weld seam are indicated by arrows in Figure 5.1 (A). Figure 5.1 (B) shows the waterside of the pipe in the region corresponding to the leakage site, after removal of corrosion products. Preferential attack surrounding the weld seam is severe.

Figure 5.1 Photographs showing (A) Weld seam leakage site on a NPS 2½ sprinkler pipe with the location of the weld seam indicated by arrows. (B) The waterside of the pipe in the region corresponding to the leakage site, after removal of corrosion products. Preferential attack surrounding the weld seam is severe.

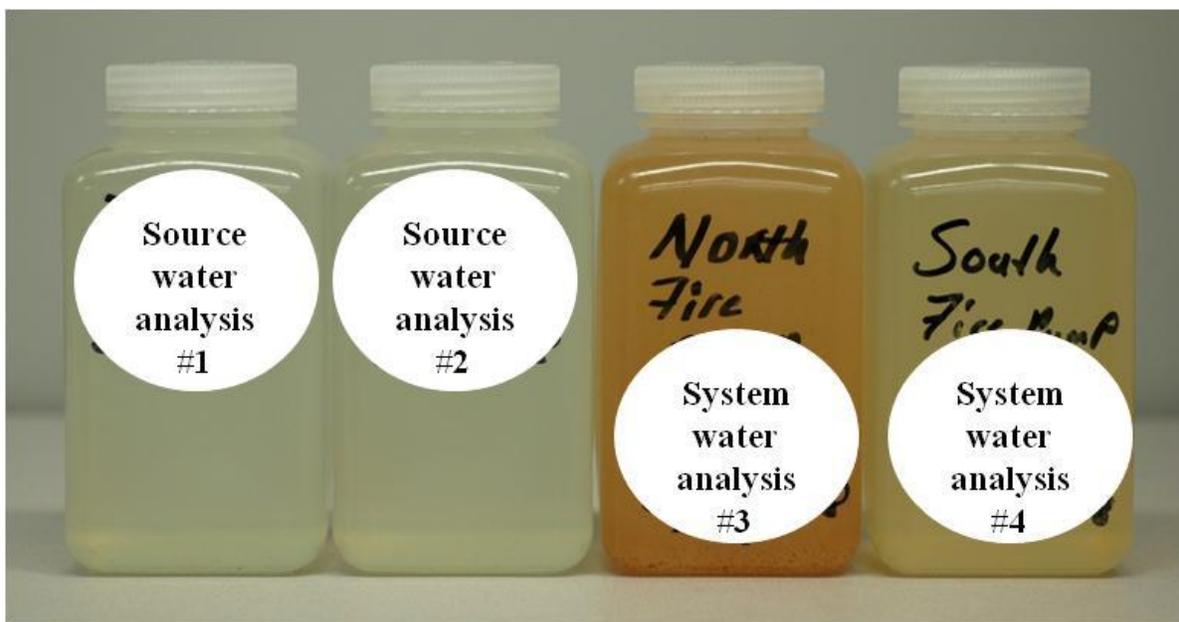
Figure 5.8 shows four water samples collected from a wet pipe system for water corrosivity analysis. Samples #1 and #2 were source water samples, while Samples #3 and #4 were fire pump line samples, respectively. The two source water samples were clear, while the fire pump water samples had a light brown and a light yellow color, respectively.

Figure 5.8 Photograph showing four water samples removed from a wet pipe system. Samples #1 and #2 were source water samples, while Samples #3 and #4 were fire pump line samples, respectively. The two source water samples were clear, while the fire pump water samples had a light brown and a light yellow color, respectively.

Chemical analyses were conducted on the four water samples in Figure 5.8; results are presented in Table 5.1. The findings were then evaluated to determine the corrosivity of the water samples to any carbon steel components with which they might come into contact. The Larson-Skold index of the water samples, calculated from their chloride, sulfate, and alkalinity values, were all determined to be over 4.77.

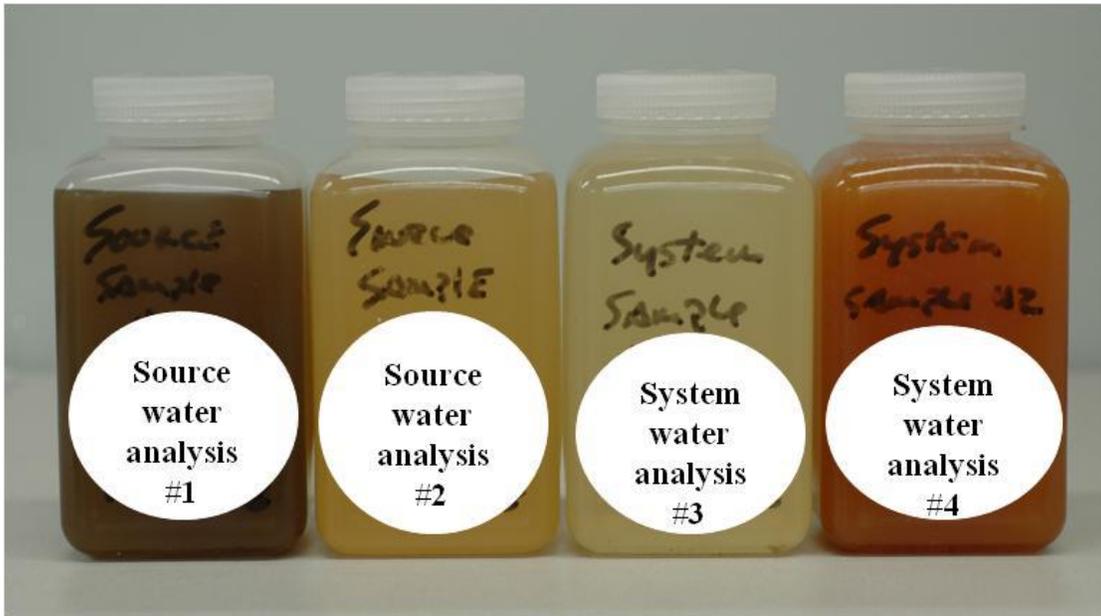
Figure 5.9 shows four water samples in a wet pipe system. Source water analysis samples #1 and #2 are source water samples, while system water analysis samples #3 and #4 are system water samples. The two source water samples are brown and light tan, and the two system water samples are yellow and reddish-brown. This facility's wet pipe fire protection system was 4-5 years old after showing pipe leakage. Two feeder line pipe samples, and two source and two sprinkler system water samples, were received for analysis. Results of water chemistry and SRB analysis are shown in Table 5.2.

The immunoassay sulfate reducing bacteria analysis of the sprinkler water samples showed that the concentration of SRB was negative (below the test's detection limit - 10^3 cells/ml), i.e., $< 10^3$ SRB bacteria were present in each 1 ml of water. Consistent with these findings, the results of the lead acetate sulfide analyses of both the sprinkler and source water samples were negative. There was also no significant reduction observed in the sulfate concentration in the sprinkler waters compared with the source waters. These results indicated that planktonic SRB concentration was below detectable limit.

Figure 5.9 Photograph showing the four water samples in a wet pipe system. samples #1 and #2 are source water samples, while samples #3 and #4 are system water samples.

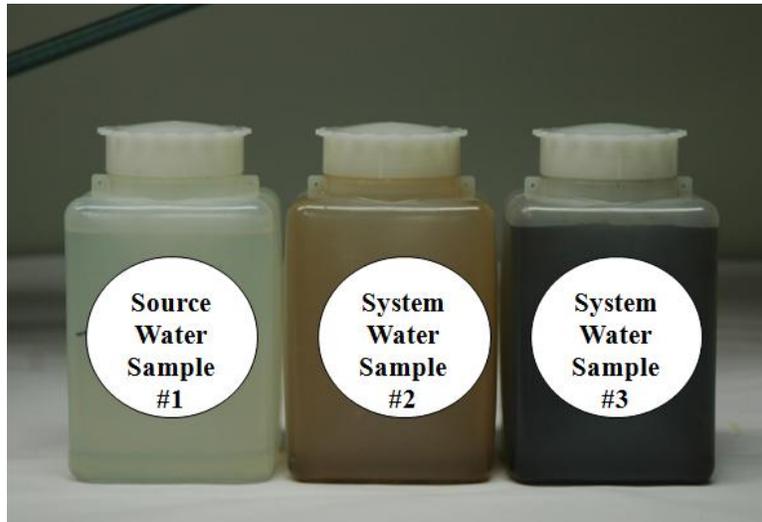
Figure 5.11 shows three water samples in a wet pipe system. Source water analysis sample #1 is the source water sample, while system water analysis samples #2 and #3 are system water samples from the 2-inch drain and the inspector test connection, respectively. This wet pipe system was over 12 years old, and no leakage had been reported in the system.

Figure 5.11 Photograph showing the three water samples in a wet pipe system. Sample #1 is from source water. Samples #2 and #3 are system water samples.

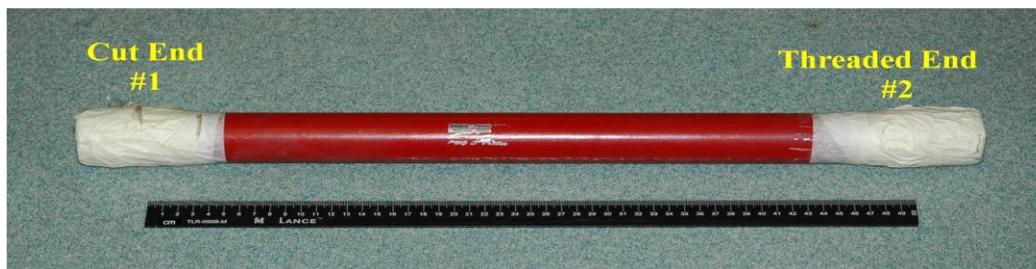
Figure 5.12 is a photograph showing an NPS 1¼ branch line pipe removed from the system. Visual examination of the inside diameter surfaces of the pipe revealed that it was in relatively good

Figure 5.12 Photograph showing an NPS 1¼ branch line pipe sample.

Table 5.3 shows SRB and APB test results of sprinkler pipe and water samples. The APB test kit results for the three water samples and the two tubercles/corrosion products/deposit buildup specimens were concluded to be strong; yet, SRB were negative and only showed very low activity in water sample #2.

In summary, corrosive water and MIC were identified as the causes contributing to pipe corrosion in this fire protection system.

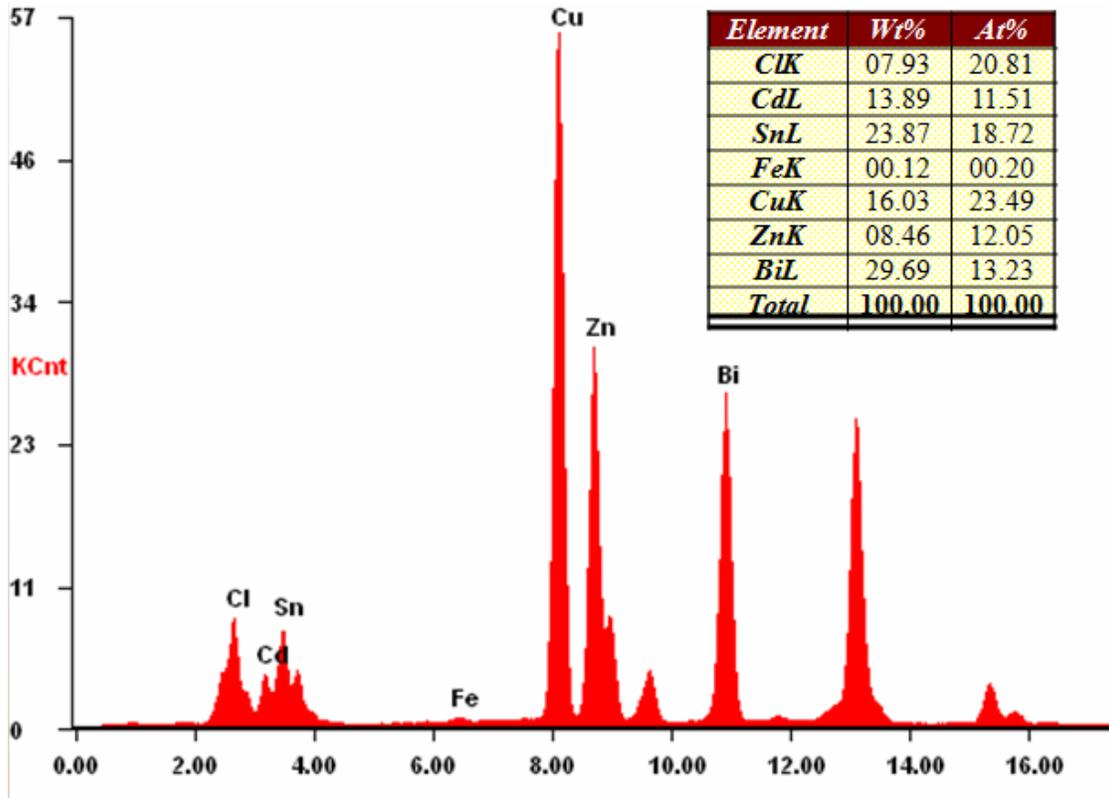
Figure 5.14 is the Xray microfluorescence spectrum of the bluish-green corrosion products/deposit buildup area circled (red) in Figure 5.15 and its standardless (semi)quantitative chemical analysis results of the XRMF spectrum. The Cu, Zn and Fe spectrum peaks in Figure 5.16 are associated with brass sprinkler compositions; the Bi, Sn and Cd peaks are from the fusible solder. The Zn and Cl spectrum peaks are related to the presence of a zinc chloride flux residue on the fusible solder.

In summary, the cause of the failure of the sprinkler head was the combined effects of the presence of trapped flux within the soldered joint, as well as the penetration of environmental gases and moisture into the joint that caused corrosion of the fusible solder. These preexisting

and in-service deterioration conditions weakened the joint, which ultimately led to its separation due to time-dependent creep.

Figure 5.16 X-ray microfluorescence spectrum of the bluish-green corrosion products/deposit buildup area circled (red) in Figure 5.15 and its standardless (semi)quantitative chemical analysis results of the XRMF spectrum.

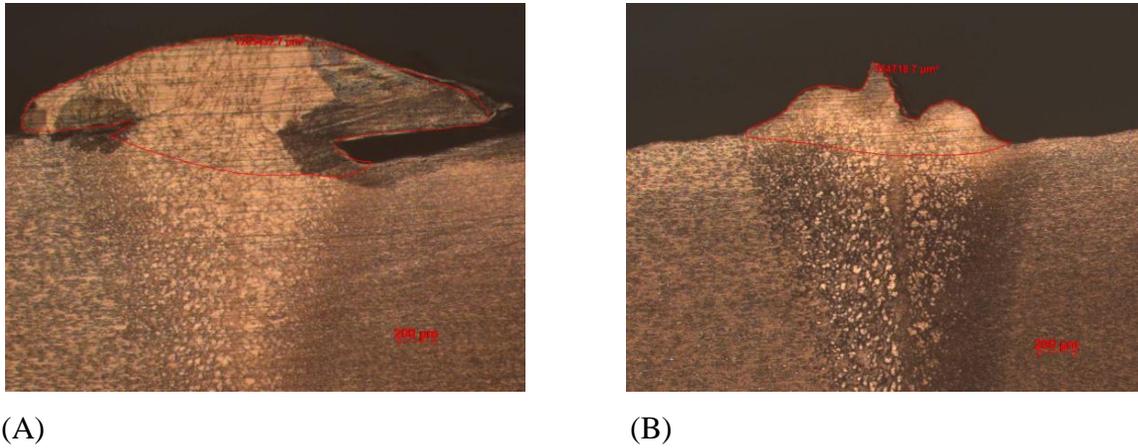
Figure 6.1 shows metallographic images of weld protrusion of pipe sections oriented in the (A) 9 o'clock (side) and at (B) 6 o'clock (bottom) directions after 12 months of exposure in aerated artificial sea water.⁶³ After 12 months of dynamic testing, the corrosion (metal loss) of the weld

located at the 6 o'clock (bottom) position is 2.7 times higher than that of the weld located at the 9 o'clock (side) position (77.7% vs. 29.1 %).⁶³

Figure 6.1 Metallographic images showing weld protrusion of pipe sections oriented at the (A) 9 o'clock and (B) 6 o'clock position (50X magnification).

To mitigate pipe weld corrosion in fire protection systems, it is recommended to: (A) orient the pipe weld seam above the 9 o'clock position (side) toward the building roof, to prevent the weld seam from being located at the 6 o'clock position (bottom) and to reduce pipe weld corrosion rate of electric-resistance welded steel pipe; (B) select steel sprinkler pipe without irregularly shaped finger-type pipe weld for better corrosion resistance of the weld seam area; and (C) reduce the frequency of introducing oxygen-rich water into the steel sprinkler piping system (e.g., periodic inspector testing) to decrease the corrosion rate of the steel.

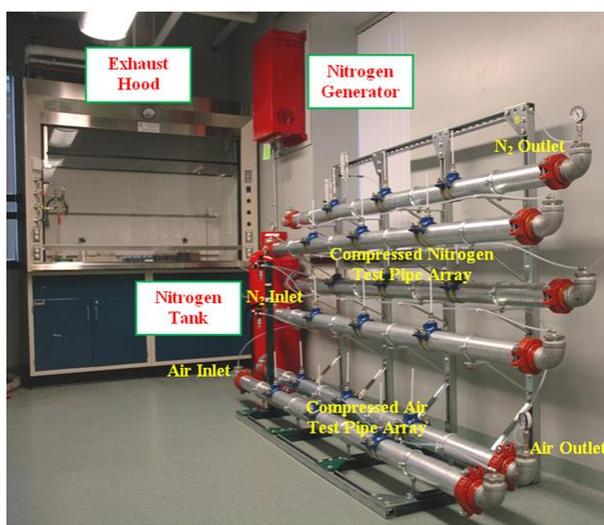
Figure 6.2 Photograph showing an overall view of the compressed nitrogen corrosion test apparatus.

Figure 6.2 is a photograph showing an overall view of a corrosion test apparatus with pressurized nitrogen and compressed air (house air) at 40 psi (0.28 MPa) and 0.2 L/min. flow rate in the pipe test racks.⁶⁷ Initially, a test rack was designed and assembled to support the six pipes containing the test coupons. The other major components that comprise this apparatus – namely, the nitrogen generator, the nitrogen receiver (storage tank), the pipe test rack containing the compressed nitrogen pipe array (top four pipe rows), and the exhaust hood – have been highlighted. The bottom two pipes visible in Figure 6.2 comprise the compressed air test pipe array, which is fed by compressed air available to the laboratory.⁶⁷

Another corrosion mitigation approach is to fill the dry pipe or preaction systems with nitrogen gas from gas cylinders or an on-site nitrogen generating system. FM Global Data Sheets 2-1⁶⁵ and 2-81⁶⁶ recommend the use of nitrogen gas as the supervisory gas where corrosion is a concern. Filling these systems with nitrogen gas can remove oxygen and decrease oxygen-related electrochemical reactions. This technique could mitigate corrosion in these dry systems based on several field trials.

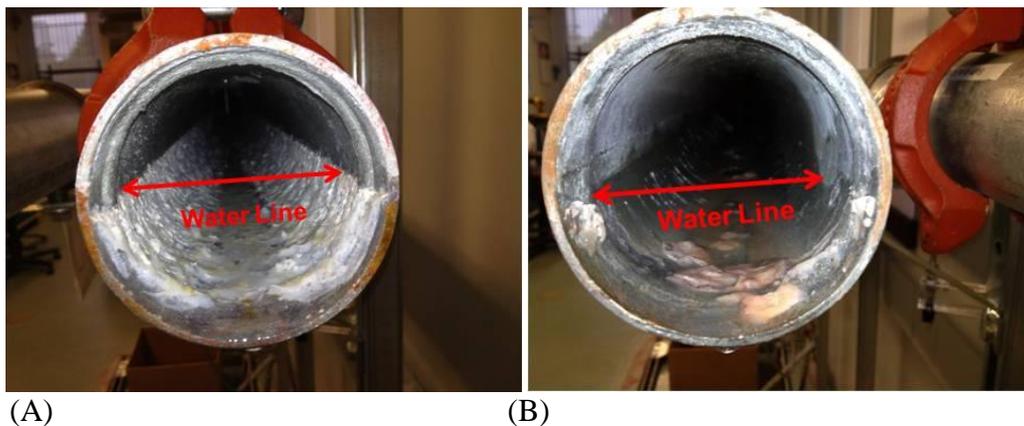
Figure 6.3 (A) and (B) shows photographs of galvanized steel pipe half-filled with tap water in (A) house air and in (B) compressed nitrogen, after nearly 6 weeks exposure. For comparison, whitish zinc corrosion products covered the bottom half of the house air-filled pipe in Figure 6.3 (A); yet, only limited zinc corrosion products covered bottom half of the compressed nitrogen-filled pipe in Figure 6.3 (B). This indicated that compressed nitrogen can reduce corrosion of galvanized steel pipe containing trapped water.^{67,68}

Figure 6.3 Photographs showing galvanized steel pipe half-filled with tap water in (A) house air and in (B) compressed nitrogen for nearly 6 weeks.

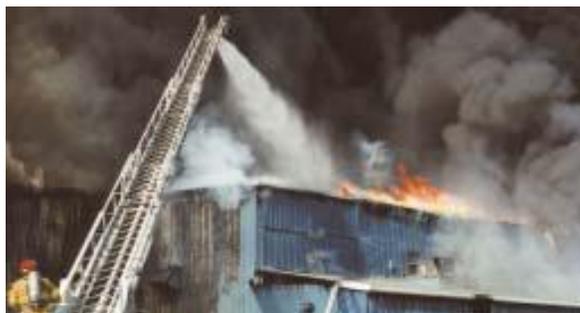
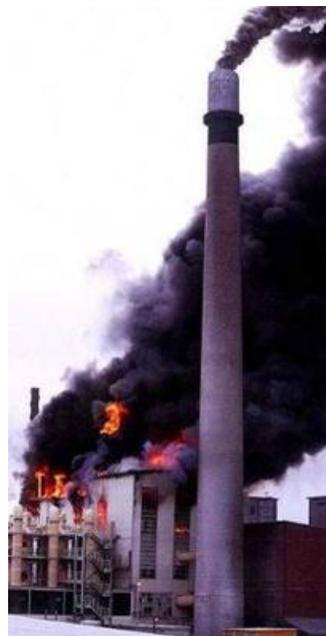
Figure 6.4 Photographs of fire incidents. (A) An unsprinklered steel pickling facility with plastic ductwork system, and (B) An unsprinklered facility with corrosive environment.

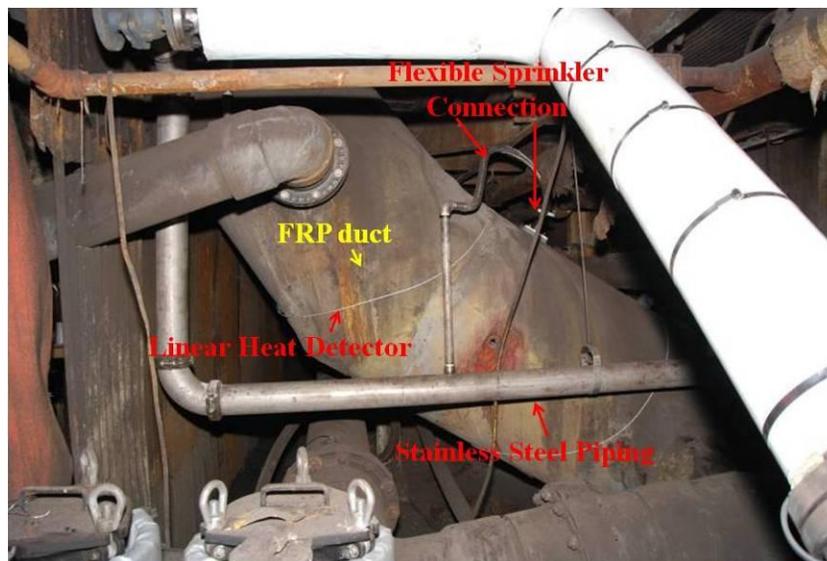
A fire protection system in the FRP exhaust duct of an HF/HNO₃ steel pickling line has been developed for field application as shown in Figure 6.5.⁷⁹ This new fire protection system is designed to protect FRP or other combustible plastic ducts with corrosive atmospheres. This system is comprised of corrosion-resistant sprinkler nozzles (see Figure 6.6),⁸⁰ linear heat detector (LHD) wires and fire control panel, flexible sprinkler connections, plus other accessories. It is designed to be suitable to protect combustible exhaust ducts from fires in extremely corrosive environments, such as high concentrations of H₂SO₄, HCl, HNO₃, and HF acids, as well as smoke.⁷⁹

Figure 6.5 Representative photograph showing part of the fire protection system protecting the main FRP exhaust duct.

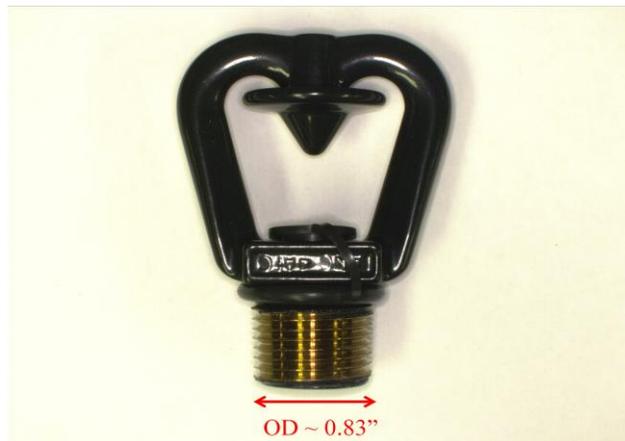
Figure 6.6 Photograph showing a corrosion-resistant nozzle with ethylene chlorotrifluoroethylene (ECTFE) coating, rounded deflector, and Teflon-based plug.
